# DAM SAFETY INSPECTION REPORT

Roaming Rock Shores Lake Dam

File Number: 1506-001

Inspection Date: October 15, 2008

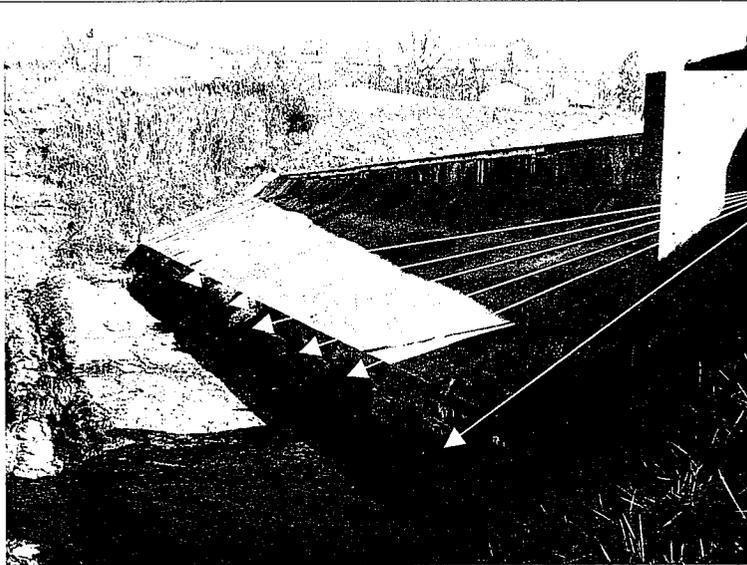
Photograph No. 5:

View of the auxiliary spillway chute outlet. Spillway under drainage weep holes are covered and plugged with vegetation.

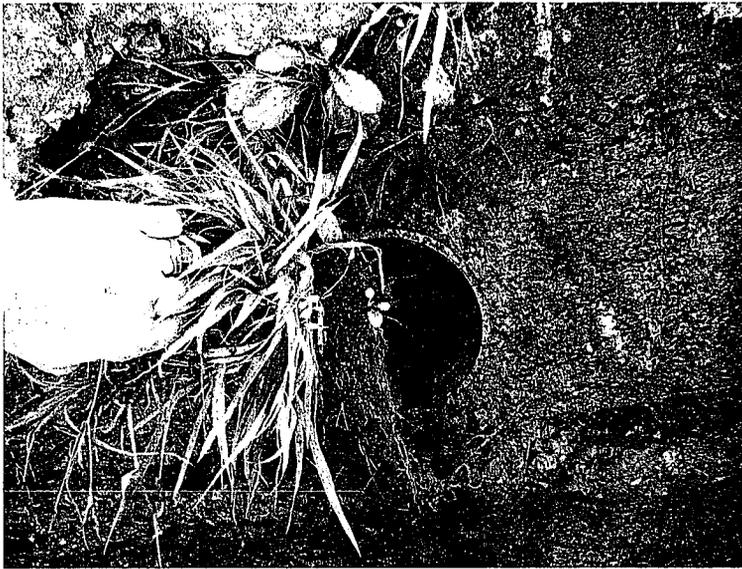
Photograph No. 7:

Close-up view of another of the plugged weep holes at the end of the auxiliary spillway outlet.

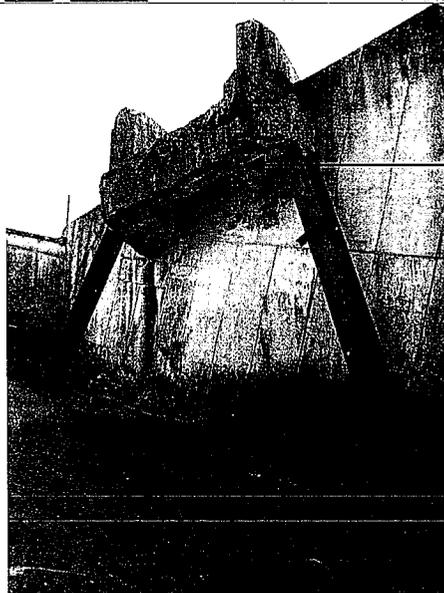
Photograph No. 12:

View of the lake drain outlet structure at the left end of the auxiliary spillway. Note the flow leaking from the structure.

4. Monitor the leakage from the lake drain system for sudden increases in flow. See the "Lake Drains" fact sheet included in this section for guidance in monitoring the lake drain and for additional information.

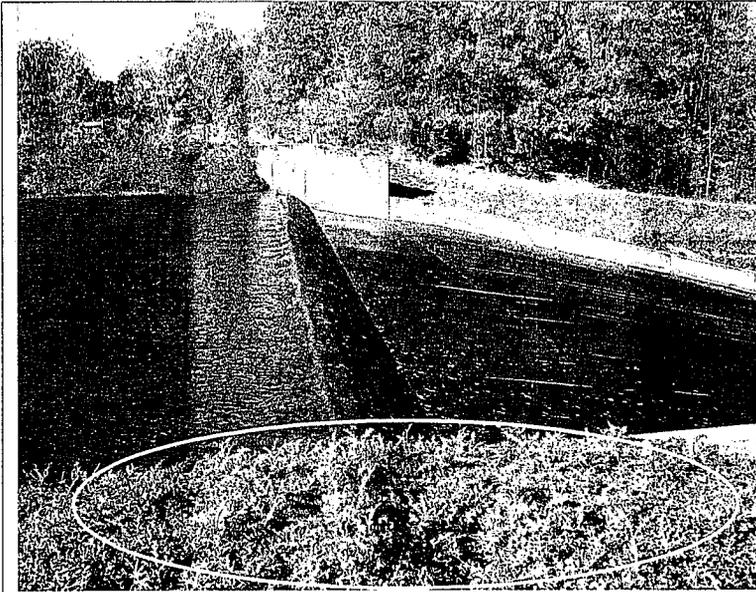
Photograph No. 16:

View of the principal spillway inlet, spillway channel and left sidewall. Note the thick crown vetch growing at the crest in the foreground.

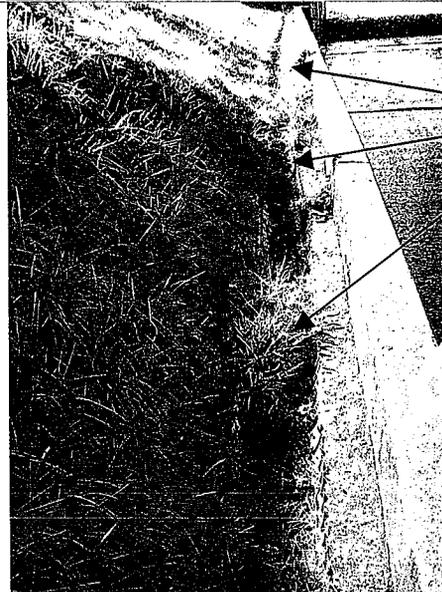
Photograph No. 18:

Note the plugged gutter drain with vegetation along much of the sidewall.

1. Repair the concrete deterioration and reapply joint sealant in the principal spillway outlet chute. Also, clean the gutter drains located behind the spillway sidewalls. See the "Open Channel Spillways (Concrete Chutes and Weirs)", "Problems with Concrete Materials", and "Concrete Repair Techniques" fact sheets and Discussion Item No. 1 included in this section for additional information.

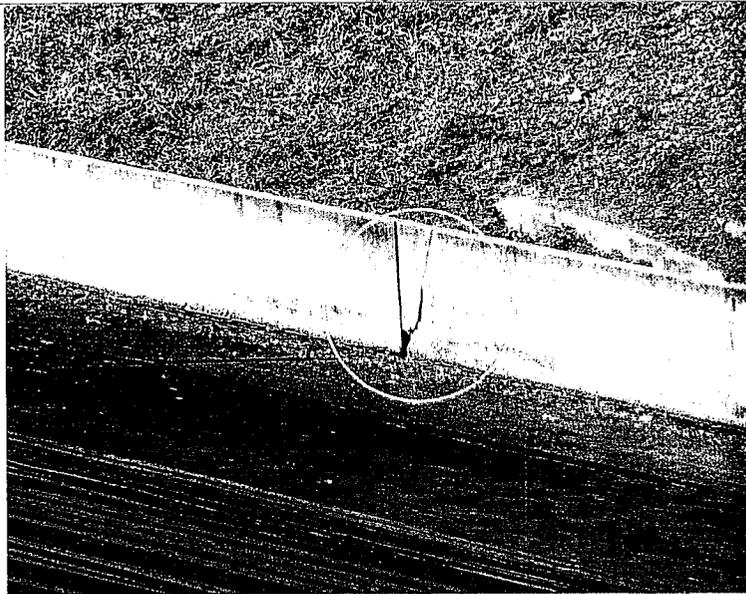
Photograph No. 20:

View of concrete deterioration and separation in a portion of the left sidewall of the principal spillway outlet.

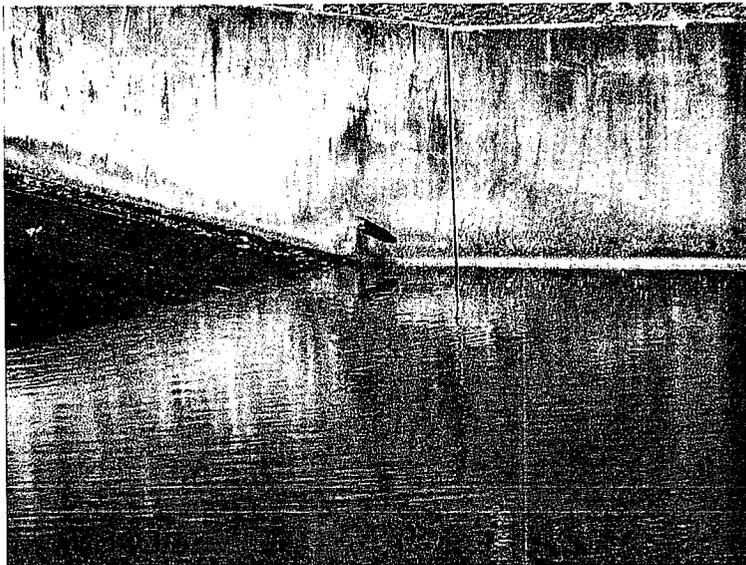
Photograph No. 21:

View of the corrugated outlet pipe to drain the collection of water behind the sidewall. The bottom of this pipe is rusted out. Investigate the integrity of the pipe.

1. The principal spillway sidewall drain system must function properly. Investigate the condition of the pipe exiting the sidewalls of the principal spillway system. As necessary, prepare plans and specifications for the repair of the drain system.

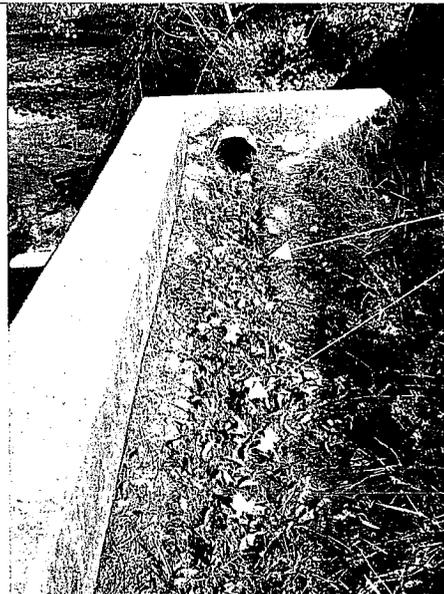
Photograph No. 24:

View of the end section of the right principal spillway sidewall. Note the plugged gutter drain.
