DAM SAFETY INSPECTION REPORT

Roaming Rock Shores Lake Dam

File Number: 1506-001

Inspection Date: October 15, 2008

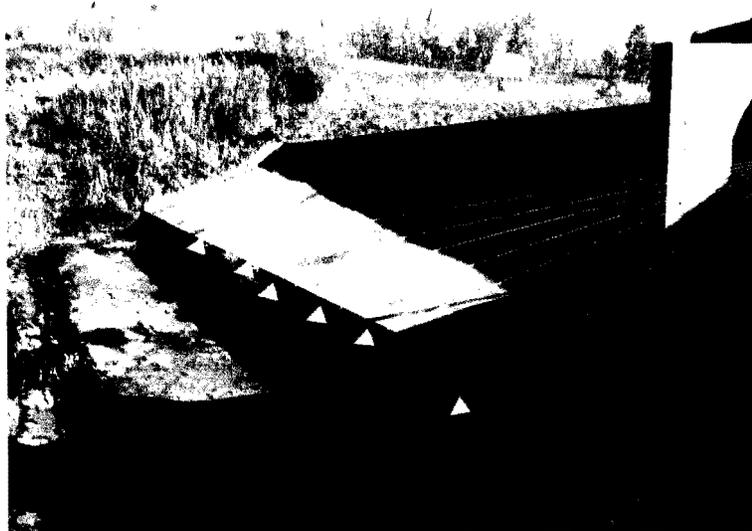
Photograph No. 5:

View of the auxiliary spillway chute outlet. Spillway under drainage weep holes are covered and plugged with vegetation.

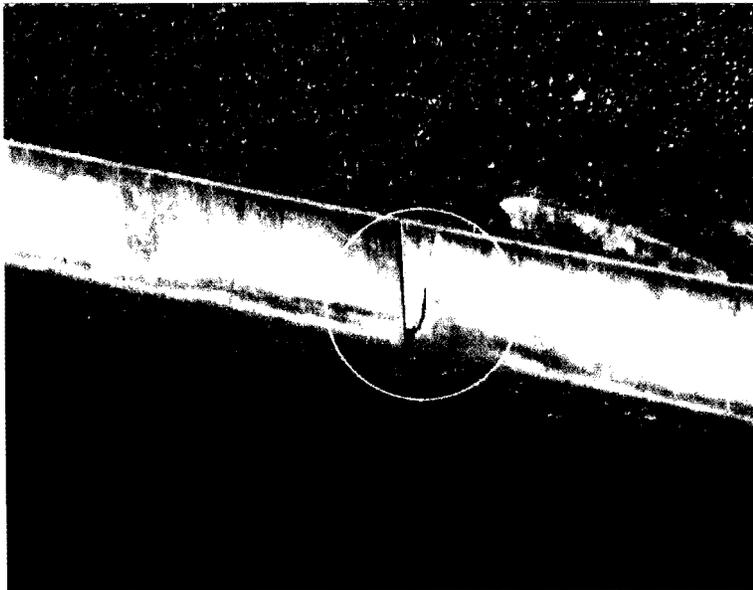
Photograph No. 20:

View of concrete deterioration and separation in a portion of the left sidewall of the principal spillway outlet.

1. Repair the concrete deterioration and reapply joint sealant in the principal spillway outlet chute. Also, clean the gutter drains located behind the spillway sidewalls. See the "Open Channel Spillways (Concrete Chutes and Weirs)", "Problems with Concrete Materials", and "Concrete Repair Techniques" fact sheets and Discussion Item No. 1 included in this section for additional information.
