DAM SAFETY INSPECTION REPORT

Roaming Rock Shores Lake Dam
File Number: 1506-001
Class I
Ashtabula County, Morgan Township
Inspection Date: October 15, 2008

DAM SAFETY INTERMEDIATE INSPECTION REPORT

Inspection Date: June 27, 2011

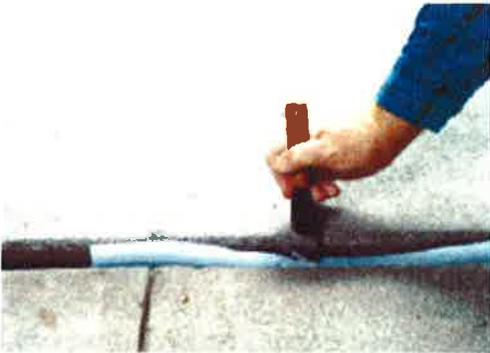
Use a putty knife to pack a strip of foam backer rod into the joint.

To repair a joint, start by removing all loose joint material and debris in the expansion joint. Clean out the joint with a wet-dry vac or compressed air. Clean the sides of the joint to clean dry concrete – grind if necessary. Do not leave any old joint adhesive, oils, greases, or other material that may prevent the new sealant from adhering. Use a putty knife to pack a strip of foam backer rod into the joint so there is firm support for the new joint sealant. Backer materials must be at a depth no greater than $\frac{1}{2}$ the width of the joint. Example, a joint 2 inches wide should have sealant no more than 1 inch in depth. Cover the backer rod and seal the joint with a liberal layer of self-leveling urethane sealant for horizontal joints. For vertical or sloping joints, a non-sagging sealant must be used. Follow manufacturer's directions and wear safety goggles and rubber gloves when applying the sealant.

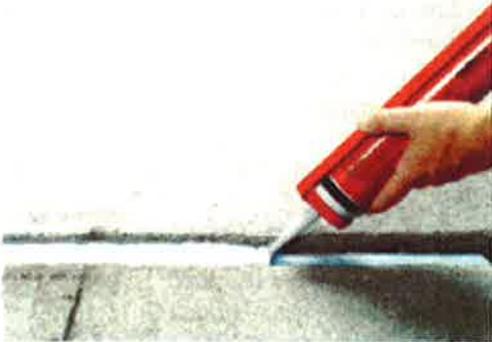
Cover the backer rod and seal the joint with a liberal layer of sealant.

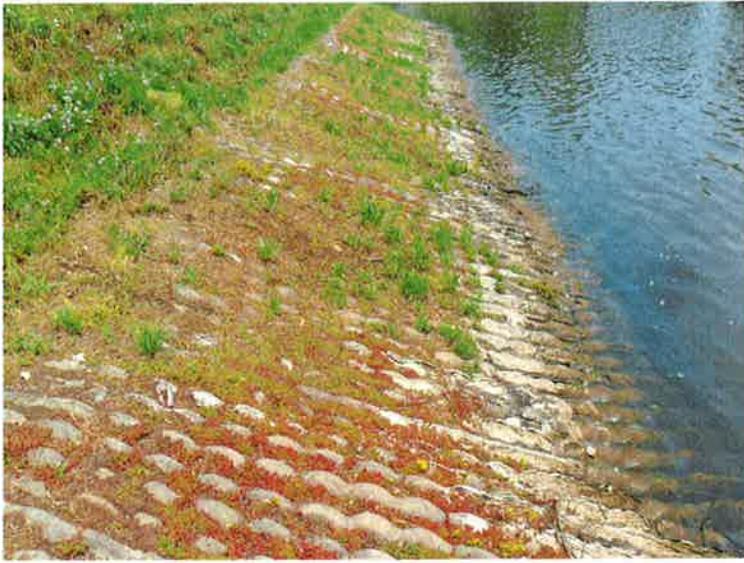
Photograph No. 1:

Upstream Slope

on going
2. Repair the rodent burrows on the upstream slope. See the "Rodent Control" fact sheet included in this section for additional information.

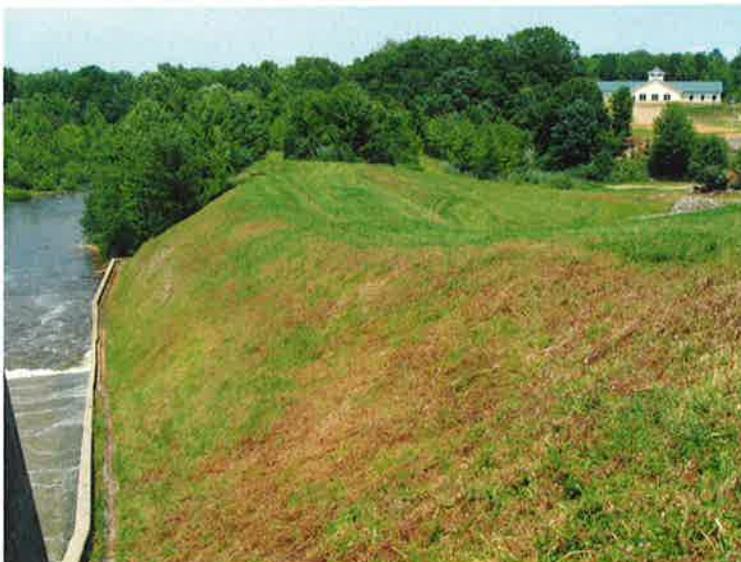
Photograph No. 9:

Principal Spillway Right Side

Not Completed
1. The principal spillway sidewall drain system must function properly. Investigate the condition of the pipe exiting the sidewalls of the principal spillway system. As necessary, prepare plans and specifications for the repair of the drain system.

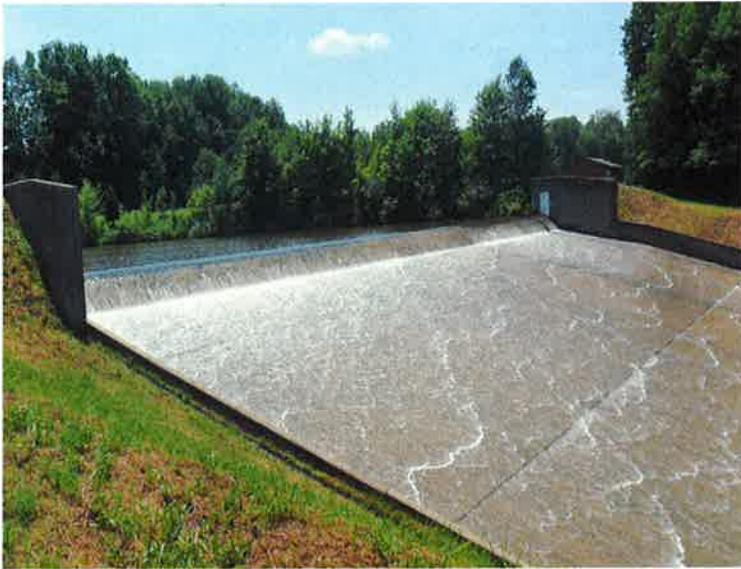
Photograph No. 10:

Principal Spillway Concrete Chute

Scheduled for Fall 2011
1. Repair the concrete deterioration and reapply joint sealant in the principal spillway outlet chute. Also, clean the gutter drains located behind the spillway sidewalls. See the "Open Channel Spillways (Concrete Chutes and Weirs)", "Problems with Concrete Materials", and "Concrete Repair Techniques" fact sheets and Discussion Item No. 1 included in this section for additional information.

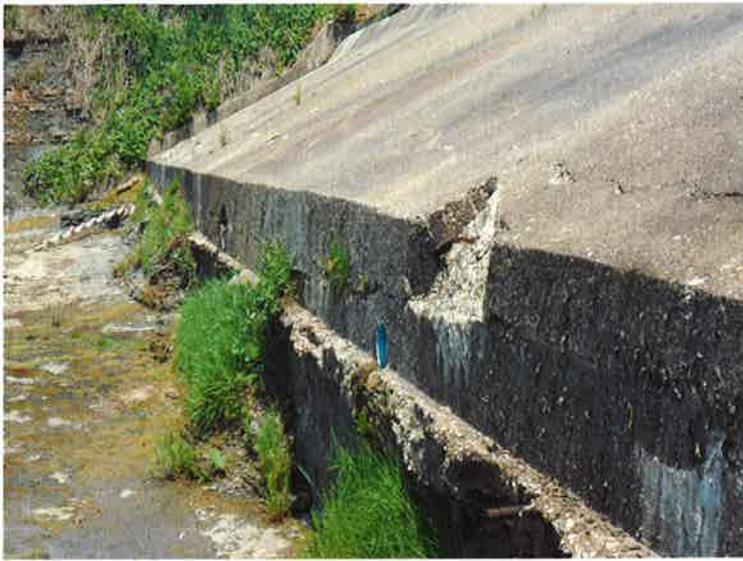
Photograph No. 16:

Auxiliary Spillway Stilling Basin

on going
3. Perform routine maintenance and clean the pipe outlets of the auxiliary spillway relief drains which exit into the stilling basin. See the "Seepage Through Earthen Dams" fact sheet included in this section for additional information.
