Operation, Maintenance, and Inspection Manual

Roaming Rock Shores Lake Dam

Village of Roaming Shores

October 2008

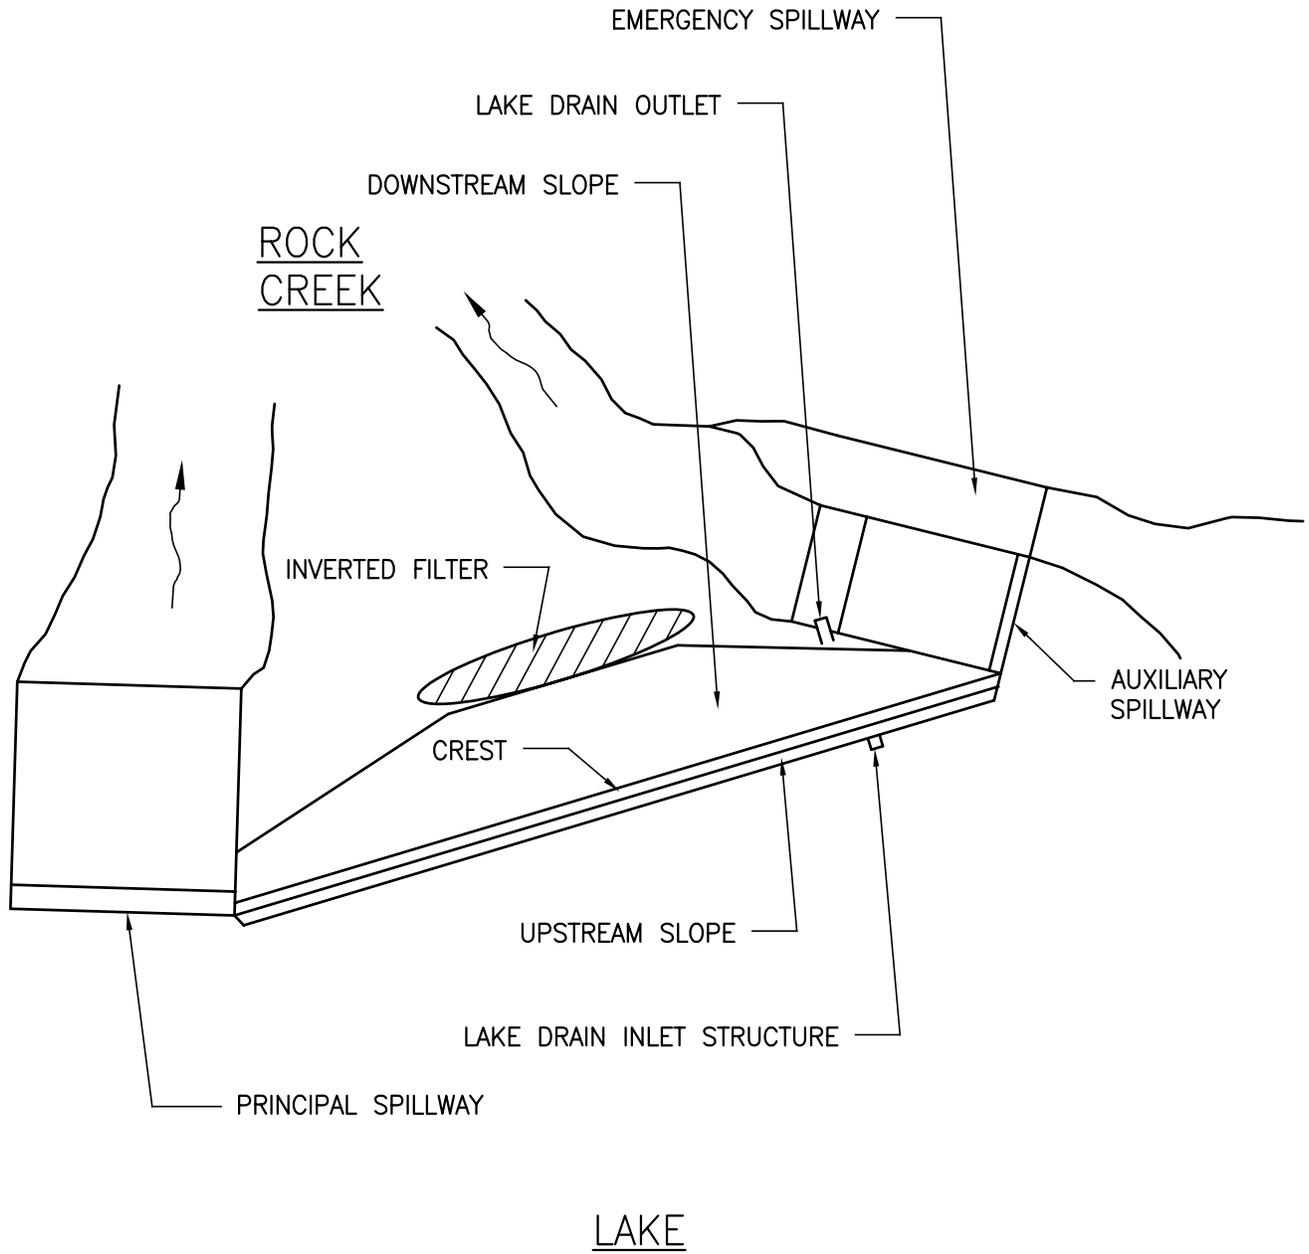
VILLAGE OF ROAMING SHORES, OHIO
OPERATION, MAINTENANCE
AND INSPECTION MANUAL
EXHIBIT 2
SITE PLAN
NOT TO SCALE
DATE: OCT. 2008
BURGESS AND NIPLE, INC.

spillway is an 80-foot wide open channel located to the right of the auxiliary spillway, with a crest elevation of 854.0, and corresponding 8,300-acre-feet of storage. The top of the dam is at Elevation 861.0 with a capacity of 12,000-acre-feet of storage. The outflow discharges into Rock Creek and flows 2.4 miles before joining the Grand River. Three piezometers, identified as P-1, P-2, and P-3, are located on the downstream side of the dam for monitoring seepage through the earthen embankment dam.

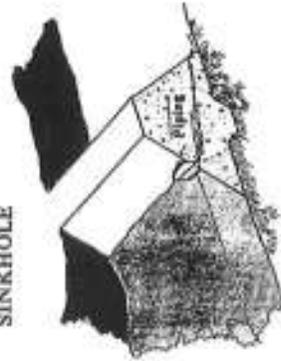
SINKHOLE

Piping or internal erosion of embankment materials or foundation causes a sinkhole. The cave-in of an eroded cavern can result in a sink hole. A small hole in the wall of an outlet pipe can develop a sink hole. Dirty water at the exit indicates erosion of the dam.

Piping can empty a reservoir through a small hole in the wall or can lead to failure of a dam as soil pipes erode through the foundation or a pervious part of the dam.

Inspect other parts of the dam for seepage or more sink holes. Identify exact cause of sink holes. Check seepage and leakage outflows for dirty water. A qualified engineer should inspect the conditions and recommend further actions to be taken.
ENGINEER REQUIRED

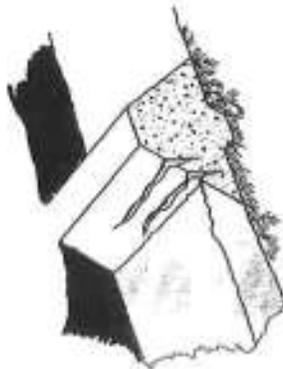
LARGE CRACKS

Indicates onset of massive slide or settlement caused by foundation failure.

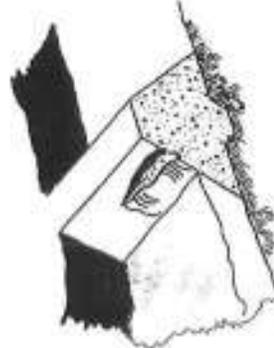
SLIDE, SLUMP OR SLIP

A series of slides can lead to obstruction of the outlet or failure of the dam.

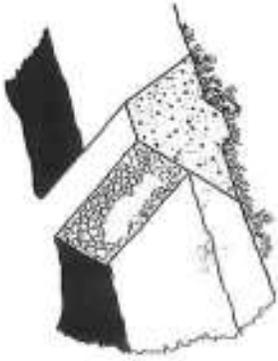
BROKEN DOWN MISSING RIPRAP

Poor quality riprap has deteriorated. Wave action or ice action has displaced riprap. Round and similar-sized rocks have rolled downhill.

Re-establish normal slope. Place bedding and competent riprap. (See Chapter 7.)

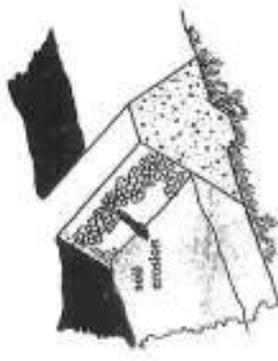
EROSION BEHIND POORLY GRADED RIPRAP

Similar-sized rocks allow waves to pass between them and erode small gravel particles and soil.

Soil is eroded away from behind the riprap. This allows riprap to settle, providing less protection and decreased embankment width.

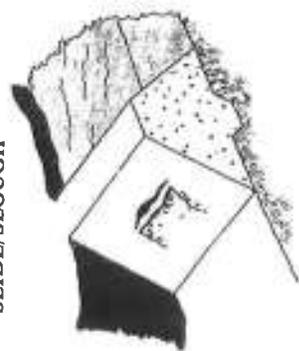
SLIDE/SLOUGH

1. Lack of or loss of strength of embankment material.
2. Loss of strength can be attributed to infiltration of water into the embankment or loss of support by the foundation.

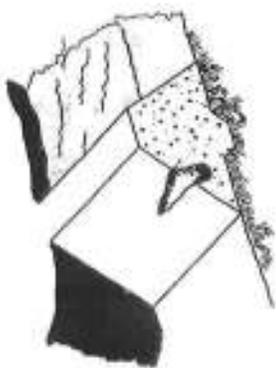
CAVE IN/COLLAPSE

1. Lack of adequate compaction.
2. Rodent hole below.
3. Piping through embankment or foundation.

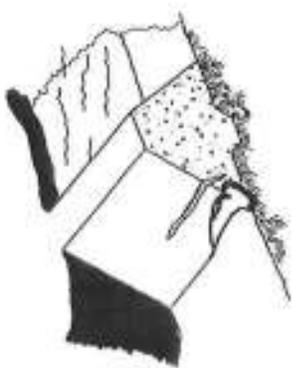
SLUMP (LOCALIZED CONDITION)

Preceded by erosion undercutting a portion of the slope. Can also be found on steep slopes.

HAZARDOUS
Settlement or shrinkage cracks can lead to seepage of reservoir water through the dam. Shrinkage cracks allow water to enter the embankment. This promotes saturation and increases freeze-thaw action.

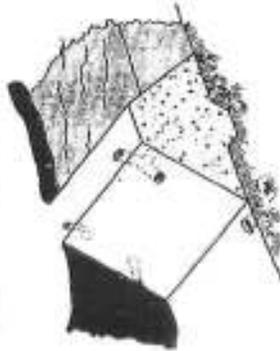
RODENT ACTIVITY

Over-abundance of rodents. Holes, tunnels and caverns are caused by animal burrowings. Certain habitats like cattail type plants and trees close to the reservoir encourage these animals.

Can reduce length of seepage path, and lead to piping failure. If tunnel exists through most of the dam, it can lead to failure of the dam.

1. Control rodents to prevent more damage.
2. Backfill existing rodent holes.
3. Remove rodents. Determine exact location of digging and extent of tunneling. Remove habitat and repair damages. (See Chapter 7.)

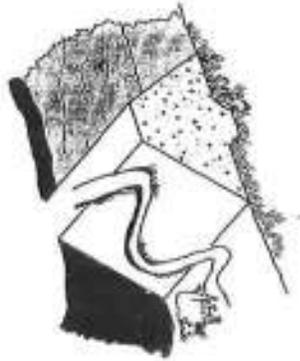
LIVESTOCK/CATTLE TRAFFIC

Excessive travel by livestock especially harmful to slope when wet.

Creates areas bare of erosion protection and causes erosion channels. Allows water to stand. Area susceptible to drying cracks.

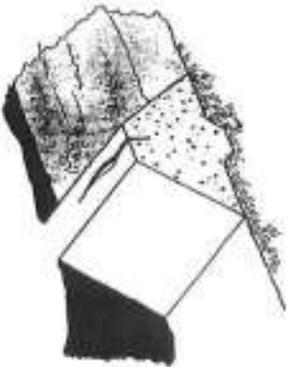
LONGITUDINAL CRACK

1. Uneven settlement between adjacent sections or zones within the embankment.
2. Foundation failure causing loss of support to embankment.
3. Initial stages of embankment slide.

1. Inspect crack and carefully record location, length, depth, width, alignment, and other pertinent physical features. Immediately stake out limits of cracking. Monitor frequently.
 2. Engineer should determine cause of cracking and supervise steps necessary to reduce danger to dam and correct condition.
 3. Effectively seal the cracks at the crest's surface to prevent infiltration by surface water.
 4. Continue to routinely monitor crest for evidence of further cracking.
- ENGINEER REQUIRED**

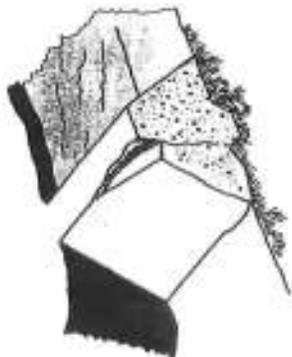
VERTICAL DISPLACEMENT

1. Vertical movement between adjacent sections of the embankment.
2. Structural deformation or failure caused by structural stress or instability, or by failure of the foundation.

1. Carefully inspect displacement and record its location, vertical and horizontal displacement, length, and other physical features. Immediately stake out limits of cracking.
 2. Engineer should determine cause of displacement and supervise all steps necessary to reduce danger to dam and correct condition.
 3. Excavate area to the bottom of the displacement. Backfill excavation using competent material and correct construction techniques, and under supervision of engineer.
 4. Continue to monitor areas routinely for evidence of future cracking or movement.
- ENGINEER REQUIRED**

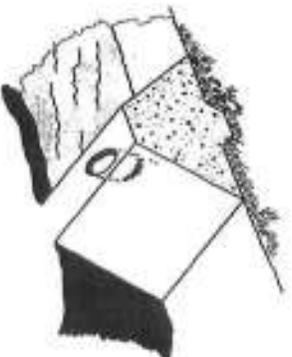
CAVE-IN ON CREST

1. Rodent activity.
2. Hole in outlet conduit is causing erosion of embankment material.
3. Internal erosion or piping of embankment material by seepage.
4. Breakdown of dispersive clays within embankment by seepage waters.

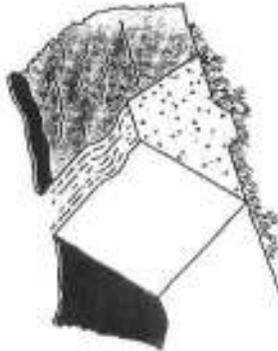
CREST MISALIGNMENT

1. Movement between adjacent parts of the structure.
2. Uneven deflection of dam under loading by reservoir.
3. Structural deformation or failure near area of misalignment.

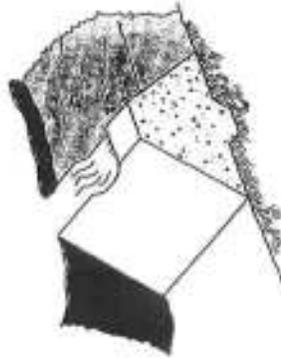
LOW AREA IN CREST OF DAM

1. Excessive settlement in the embankment or foundation directly beneath the low area in the crest.
2. Internal erosion of embankment material.
3. Foundation spreading to upstream and/or downstream direction.
4. Prolonged wind erosion of crest area.
5. Improper final grading following construction.

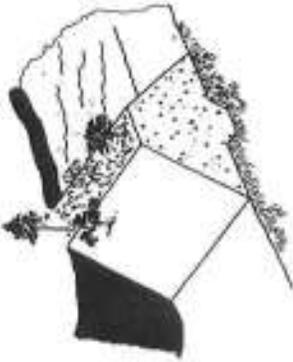
OBSCURING VEGETATION

Neglect of dam and lack of proper maintenance procedures.

1. Remove all damaging growth from the dam. This would include removal of trees, bushes, brush, conifers, and growth other than grass. Grass should be encouraged on all segments of the dam to prevent erosion by surface runoff. Root systems should also be removed to the maximum practical extent. The void which results from removing the root system should be backfilled with well-competent, well-compacted material.
2. Future undesirable growth should be removed by cutting or spraying, as part of an annual maintenance program. (See Chapter 7.)
3. All cutting or debris resulting from the vegetative removal should be immediately taken from the dam and properly disposed of outside the reservoir basin.

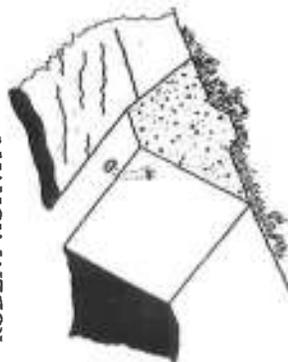
RODENT ACTIVITY

Burrowing animals.

1. Entrance point for surface runoff to enter dam. Could saturate adjacent portions of the dam.
2. Especially dangerous if hole penetrates dam below phreatic line. During periods of high storage, seepage path through the dam would be greatly reduced and a piping situation could develop.

1. Completely backfill the hole with competent, well-compacted material.
2. Initiate a rodent control program to reduce the burrowing animal population and to prevent future damage to the dam. (See Chapter 7.)

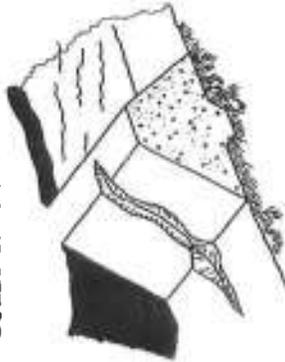
GULLY ON CREST

1. Poor grading and improper drainage of crest. Improper drainage causes surface runoff to collect and drain of crest at low point in upstream or downstream shoulder.
2. Inadequate spillway capacity which has caused dam to overtop.

1. Can reduce available freeboard.
2. Reduces cross-sectional area of dam.
3. Inhibits access to all parts of the crest and dam.
4. Can result in a hazardous condition if due to overtopping.

1. Restore freeboard to dam by adding fill material in low area, using proper construction techniques. (See Chapter 7.)
2. Regrading crest to provide proper drainage of surface runoff.
3. If gully was caused by overtopping, provide adequate spillway which meets current design standards. This should be done by engineer.
4. Re-establish protective cover.

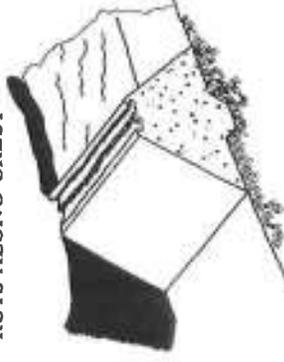
RUTS ALONG CREST

Heavy vehicle traffic without adequate or proper maintenance or proper crest surfacing.

1. Inhibits easy access to all parts of crest.
2. Allows continued development of rutting.
3. Allows standing water to collect and saturate crest of dam.
4. Operating and maintenance vehicles can get stuck.

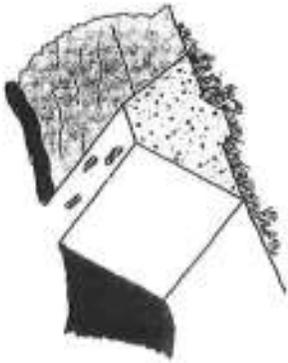
**PUDDLING ON CREST-
POOR DRAINAGE**

1. Poor grading and improper drainage of crest.
2. Localized consolidation or settlement on crest allows puddles to develop.

1. Drain standing water from puddles.
2. Regrade and recompact crest to restore integrity and provide proper drainage to upstream slope. (See Chapter 7.)
3. Provide gravel or roadbase material to accommodate traffic.
4. Do periodic maintenance and regrading to prevent reformation of low areas.

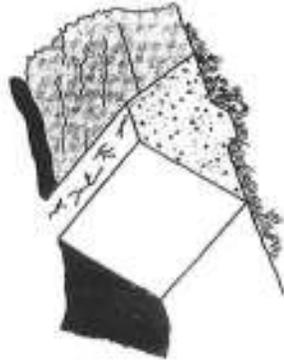
DRYING CRACKS

Material on the crest of dam expands and contracts with alternate wetting and drying of weather cycles. Drying cracks are usually short, shallow, narrow, and many.

Provides point of entrance for surface runoff and surface moisture, causing saturation of adjacent embankment areas. This saturation, and later drying of the dam, could cause further cracking.

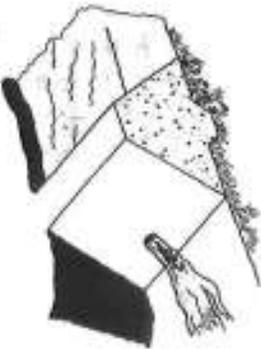
EXCESSIVE QUANTITY AND/OR MUDDY WATER EXITING FROM A POINT

1. Water has created an open pathway, channel, or pipe through the dam. The water is eroding and carrying embankment material.
2. Large amounts of water have accumulated in the downstream slope. Water and embankment materials are exiting at one point. Surface agitation may be causing the muddy water.
3. Rodents, frost action or poor construction have allowed water to create an open pathway or pipe through the embankment.

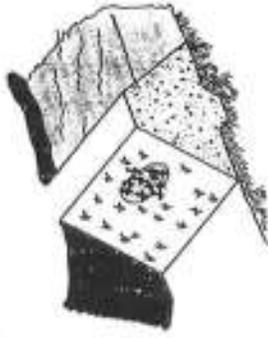
MARKED CHANGE IN VEGETATION

Can show a saturated area.

- 1. Embankment material are supplying flows paths.
- 2. Natural seeding by wind.
- 3. Change in seed type during early post construction seeding.

- 1. Use probe and shovel to establish if the materials in this area are wetter than surrounding areas.
 - 2. If areas shows wetness, when surrounding areas do not, a qualified engineer should inspect the condition and recommend further actions to be taken.
- ENGINEER REQUIRED

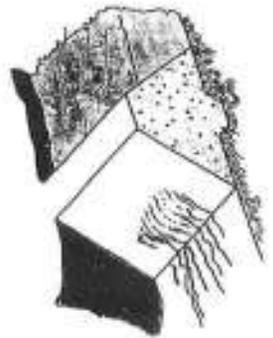
BULGE IN LARGE WET AREA

Failure of the embankment result from massive sliding can follow these early movements.

- 1. Compare embankment cross section to the end of construction condition to see if observed condition may reflect end of construction.
 - 2. Stake out affected area and accurately measure outflow.
 - 3. A qualified engineer should inspect the condition and recommend further actions to be taken.
- ENGINEER REQUIRED

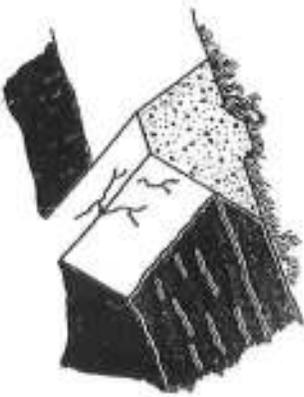
CRACKS DUE TO DRYING

The soil loses its moisture and shrinks, causing cracks. **NOTE:** Usually seen on crest and downstream slope mostly.

Heavy rains can fill up cracks and cause small parts of embankment to move along internal slip surface.

1. Monitor cracks for increases in width, depth, or length.
 2. A qualified engineer should inspect the condition and recommend further actions to be taken.
ENGINEER REQUIRED

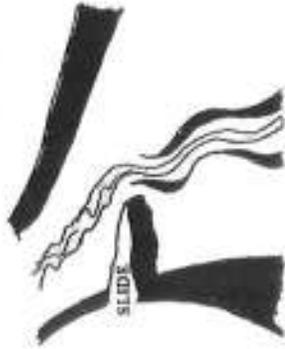
END OF SPILLWAY CHUTE
UNDERCUT

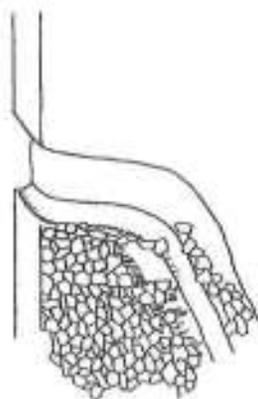
BREAKDOWN AND LOSS OF RIPRAP

Slope too steep; material poorly graded; failure of subgrade; flow velocity too high; improper placement of material; bedding material or foundation washed away.

Erosion of channel bottom and banks; failure of spillway.

Design a stable slope for channel bottom and banks. Riprap material should be well graded (the material should contain small, medium, and large particles). Sub-grade should be properly prepared before placement of riprap. Install filter fabric if necessary. Control flow velocity in the spillway by proper design. Riprap should be placed according to specification. Services of an engineer are recommended.

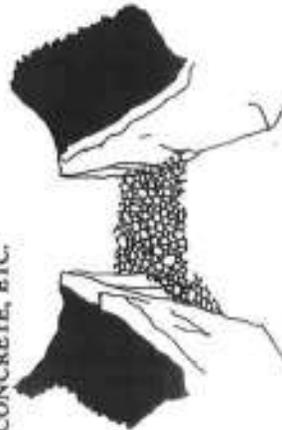
MATERIAL DETERIORATION- SPALLING AND DISINTEGRATION OF RIPRAP, CONCRETE, ETC.

Use of unsound or defective materials; structures subject to freeze-thaw cycles; improper maintenance practices; harmful chemicals.

Structure life will be shortened; premature failure.

Avoid using shale or sandstone for riprap. Add air-entraining agent when mixing concrete. Use only clean good quality aggregates in the concrete. Steel bars should have at least 1 inch of concrete cover. Concrete should be kept wet and protected from freezing during curing. Timber should be treated before using.

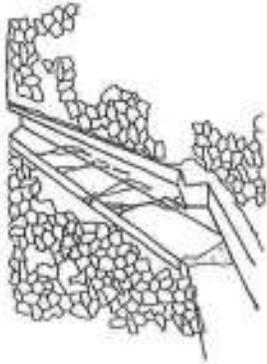
POOR SURFACE DRAINAGE

No weep holes; no drainage facility; plugged drains.

Wet foundation has lower supporting capacity; uplift pressure resulting from seepage water may cause damage to spillway chute; accumulation of water may also increase total pressure on spillway walls and cause damage.

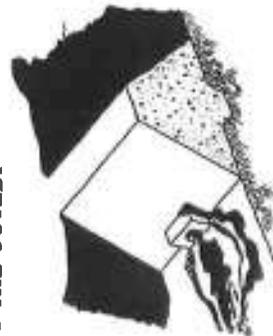
**SEEPAGE WATER EXITING
FROM A POINT ADJACENT
TO THE OUTLET**

1. A break in the outlet pipe.
2. A path for flow has developed along the outside of the outlet pipe.

HAZARDOUS
Continued flows can lead to rapid erosion of embankment materials and failure of the dam.

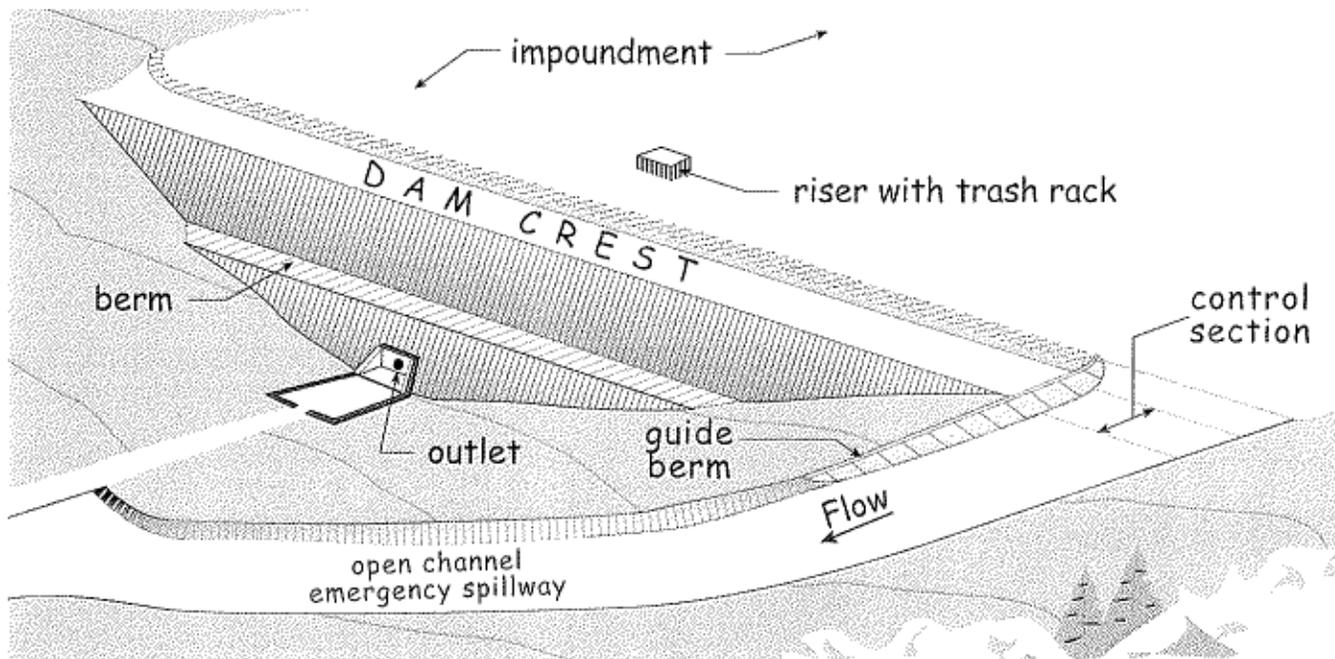
Downstream View of Open Channel Spillway

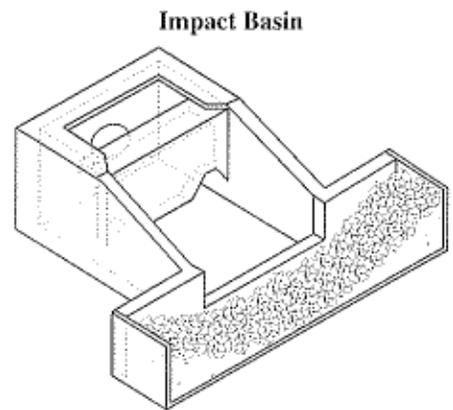
A concrete impact basin is an energy dissipating device located at the outlet of the spillway in which flow

strikes a vertical hanging baffle. Discharge is directed upstream in vertical eddies by the horizontal portion of the baffle and by the floor before flowing over the endsill. Energy dissipation occurs

as the discharge strikes the baffle, thus, performance is not dependent on tailwater. Most impact basins were designed by the United States Department of Agriculture, Natural Resources Conservation Service and the United States Department of Interior, Bureau of Reclamation. If any of the severe defects that are referenced in the opening paragraphs are observed, a registered professional engineer should be contacted to evaluate the stability of the outlet.

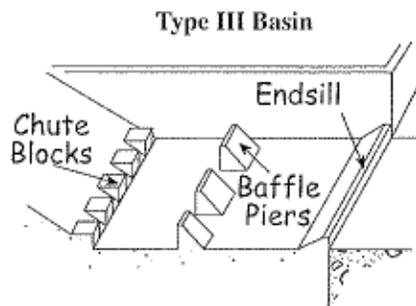
U.S. Department of Interior, Bureau of Reclamation Type II and Type III Basins

Type II and Type III basins reduce the energy of the flow discharging from the outlet of a spillway and allow the water to exit into the outlet channel at a reduced velocity. Type II energy dissipators contain chute blocks at the upstream end of the basin and a dentated (tooth-like) endsill. Baffle piers are not used in a Type II basin because of the high velocity water entering the basin.

Type III energy dissipators can be used if the entrance velocity of the water is not high. They contain baffle piers which are located on the stilling basin apron downstream of

the chute blocks. Located at the end of both the Type II and Type III basins is an endsill. The endsill may be level or sloped, and its purpose is to create the tailwater which reduces the outflow velocity. If any of the severe defects associated with concrete structures are observed, a registered professional engineer should be contacted to evaluate the stability of the basin.

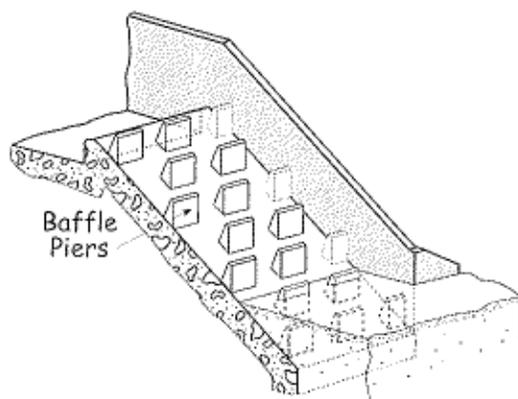
Baffled chutes require no initial tailwater to be effective and are located downstream of the control section. Multiple rows of baffle piers on the chute prevent excessive acceleration of the flow and prevent the damage that occurs from a high discharge velocity. A portion of the baffled chute usually extends below the streambed elevation to prevent undermining of the chute. If any of the severe problems associated with concrete that are referenced in the opening paragraphs are observed, a registered professional engineer should be contacted to evaluate the stability of the outlet.

Baffled Chute Basin

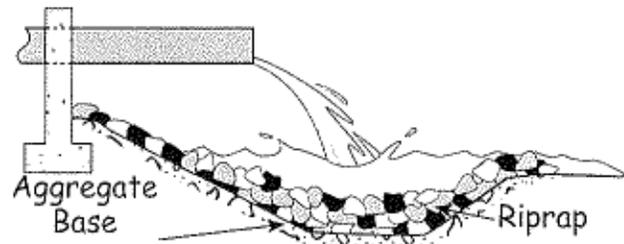
A plunge pool is an energy dissipating device located at the outlet of a spillway. Energy is dissipated as the discharge flows into the plunge pool. Plunge pools are commonly lined with rock riprap or other material to prevent excessive erosion of the pool area. Discharge from the plunge pool should be at the natural streambed elevation. Typical problems may include movement of the riprap, loss of fines from the bedding material and scour beyond the riprap and lining. If scour beneath the outlet

Plunge Pool

conduit develops, the conduit will be left unsupported and separation of the conduit joints and undermining may occur. Separation of the conduit joints and undermining may lead to failure of the spillway and ultimately the dam. A registered professional engineer should be contacted to ensure that the plunge pool is designed properly.

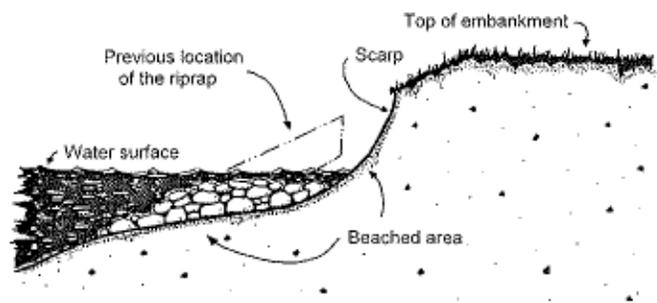
Figure 1 - Beaching

The repeated action of waves striking the embankment surface erodes fill material and displaces it farther down the slope, creating a “beach.” The amount of erosion depends on the predominant wind direction, the orientation of the dam, the steepness of the slope, water level fluctuations, boating activities, and other factors. Further erosion can lead to cracking and sloughing of the slope which can extend into the crest, reducing its width. When erosion occurs and beaching develops on the upstream slope of a dam, repairs should be made as soon as possible. However, an erosion scarp less than 1 foot high may be stable and not require repair.

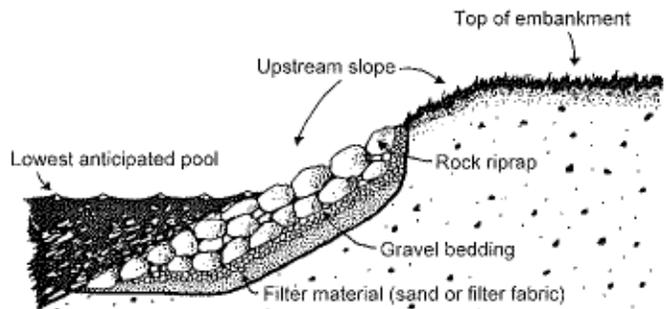
Rock riprap consists of a heterogeneous mixture of irregular shaped rocks placed over gravel bedding and a sand filter or geotextile fabric. The smaller rocks help to fill the spaces between the larger pieces forming an interlocking mass. The filter prevents soil particles on the embankment surface from being washed out through the spaces (or voids) between the rocks. The maximum rock

size and weight must be large enough to break up the energy of the maximum anticipated wave action and hold the smaller stones in place. If the rock size is too small, it will eventually be displaced and washed away by wave action. If the riprap is sparse or if the filter or bedding material is too small, the filter material will wash out easily, allowing the embankment material to erode. Once the erosion has started, beaching will develop if remedial measures are not taken. Technical Release No. 69 developed by the USDA, Natural Resources Conservation Service can be used to help design engineers develop a preliminary or detailed design for riprap slope protection.

Figure 2 - Rock Riprap

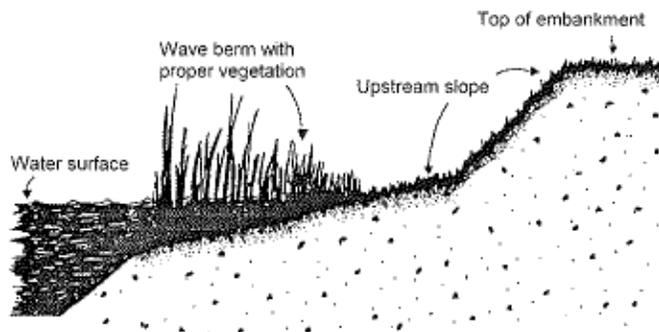
Vegetated wave berms dissipate wave energy and protect the slope from erosion. Berms are constructed on the upstream slope at the normal pool level and should be no less than 20 feet wide. This method of slope protection will not work well where the water surface fluctuates regularly from normal pool. If improper or sparse vegetation is present, the wave berm may not adequately dissipate the wave energy, allowing erosion and beaching to develop on the upstream slope. Technical Release No. 56 developed by the USDA, Natural Resources Conservation Service provides design and layout information.

Figure 3 - Vegetated wave berm

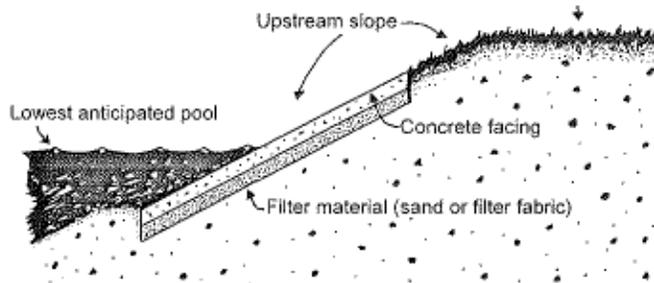
Concrete facing can be used if severe wave action is anticipated, however, settlement of the embankment must be insignificant to insure adequate support for the concrete facing. A properly designed and constructed concrete facing can be expensive. This slope protection should extend several feet above and below the normal pool level. It should terminate on a berm or against a concrete curb or header. Granular filter or filter fabric (geotextile) is required under the concrete facing to help reduce the risk of undermining.

Figure 4 - Concrete facing

As with any type of slope protection, problems will develop if the concrete facing has not been properly designed or installed. Concrete facing often fails because the wave action washes soil particles from beneath the slabs through joints and cracks. This process is known as undermining, which will continue until large voids are created. Detection of voids is difficult because the voids are hidden. Failure of the concrete facing may be sudden and extensive. Concrete facing should be monitored for cracks and open joints. Open joints should be sealed with plastic fillers and cracks should be grouted and sealed. For additional information, see the "Problems with Concrete Materials" fact sheet.

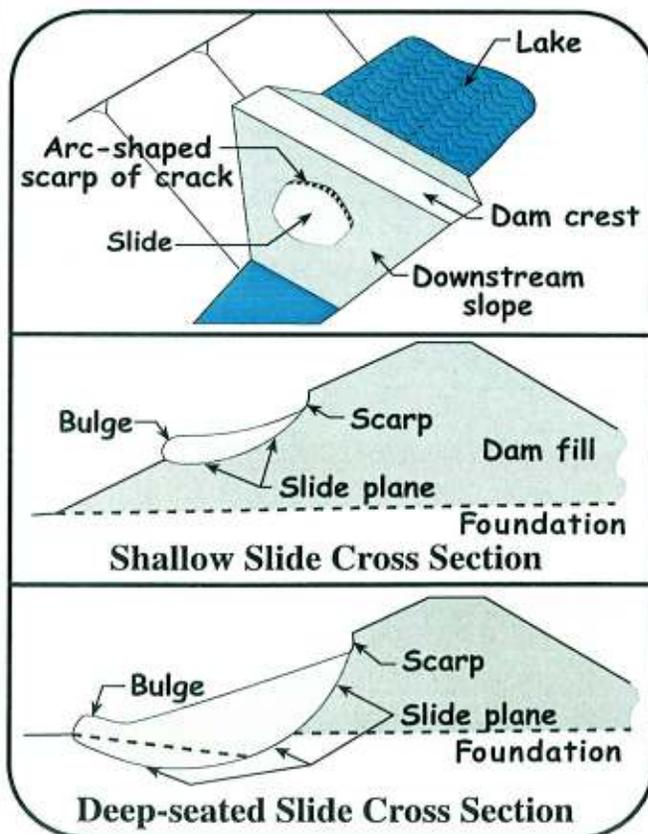
A slide in an embankment or in natural soil or rock is a mass movement of material. Some typical characteristics of a slide are an arc-shaped crack or scarp along the top and a bulge along the bottom of the slide (see drawing). Slides may develop because of poor soil compaction, the

gradient of the slope being too steep for the embankment material, seepage, sudden drawdown of the lake level, undercutting of the embankment toe, or saturation and weakening of the embankment or foundation.

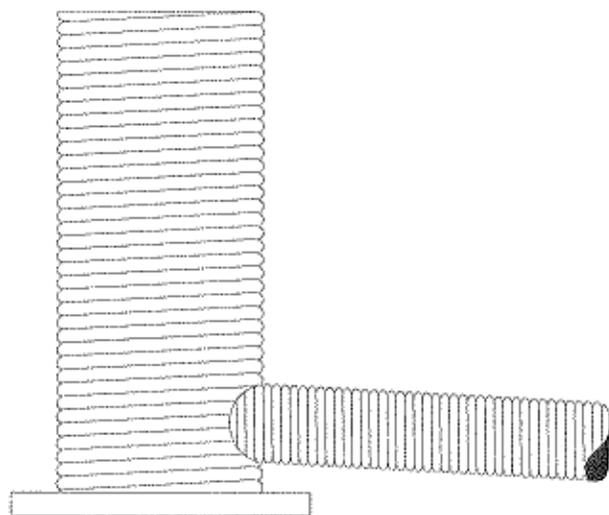
Corrosion is a common problem for spillway conduits and other metal appurtenances. Corrosion is the deterioration or breakdown of metal because of a reaction with its environment. Exposure to moisture, acidic conditions, or salt will accelerate the corrosion process. Acid runoff from strip-mined areas will cause rapid corrosion of metal conduits. In these areas, conduits made of less corrodible materials such as concrete or plastic should be used. Soil types also factor into the amount of corrosion. Clayey soils can be more corrosive than sandy soils since they are poorly drained and poorly aerated. Silts are somewhere in between clays and sands. Some examples of metal conduits include ductile iron, smooth steel, and corrugated metal. Corrugated metal pipe is not recommended for use in dams since the service life for corrugated metal is only 25 to 30 years, whereas the life expectancy for dams is much longer. In areas of acidic water, the service life can be much less. Therefore, corrugated metal spillway conduits typically need to be repaired or replaced early in the dam's design life, which can be very expensive.

Figure 1 – Example of a corrugated metal pipe and riser spillway.

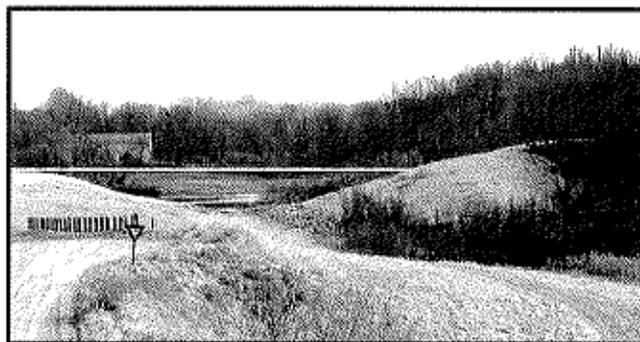
Description: A breach is defined as an opening in a dam that prevents the dam from impounding a significant amount of water (see photograph). A breach extends from the upstream side of the embankment to the downstream side and typically has mild side slopes. A dam breach could be considered partial removal of a dam. Breaching the dam alleviates the need to obtain a construction permit or to address the required remedial measures listed in the inspection report.

Photograph of dam breach from downstream. White line shows former dam crest, and arrow shows center of breach.
